**Docket No. 217 – Development and Management Plan Inspection**

Northeast Utilities Service Company Certificate of Environmental Compatibility and Public Need for the construction of a 345-kV electric transmission line and reconstruction of an existing 115-kV electric transmission line between Connecticut Light and Power Company's Plumtree Substation in Bethel, through the towns of Redding, Weston, and Wilton, and to the Norwalk Substation in Norwalk, Connecticut.

**Date:** July 12, 2006

**Location:** Overhead Line (Composite 345kV and 115kV Gallows Hill to Archers Lane,  
345kV H-Frame Hoyts Hill to Gallows Hill, and Norwalk Section)

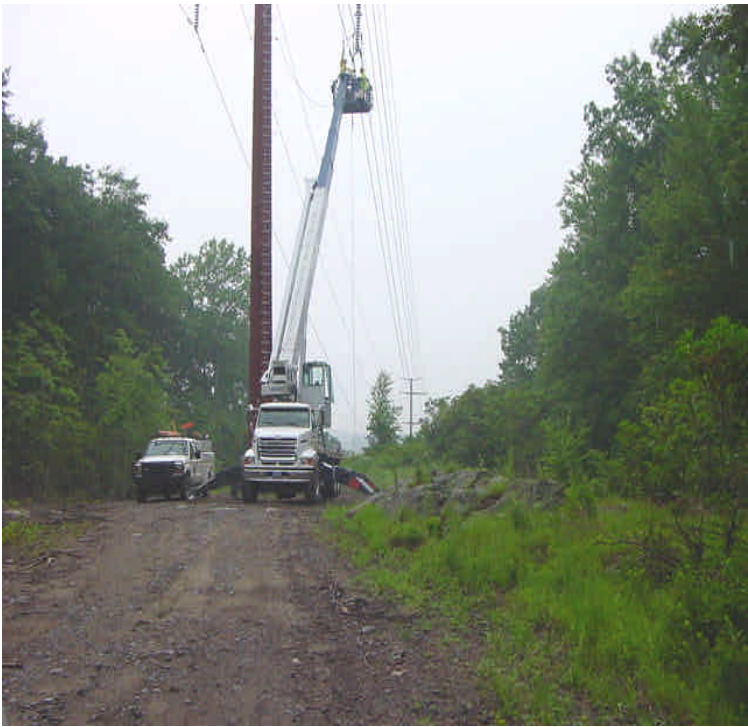
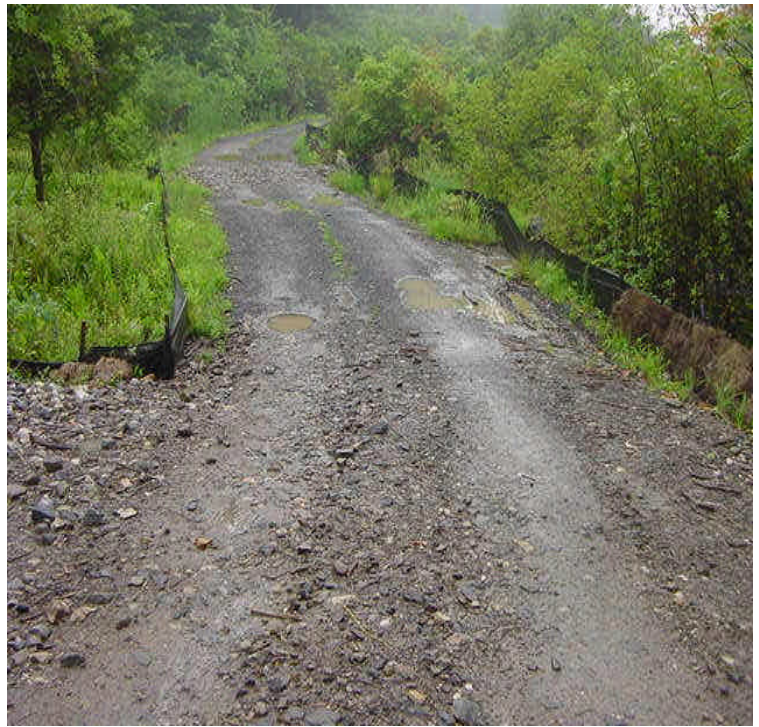
**(Composite Section):** Photo on the left shows crews working on clipping in the wire along the Archers Lane ROW. Photo on the right shows the wetland crossing off Gallows Hill Rd. Water within the wetland remains clear. 7/12/06

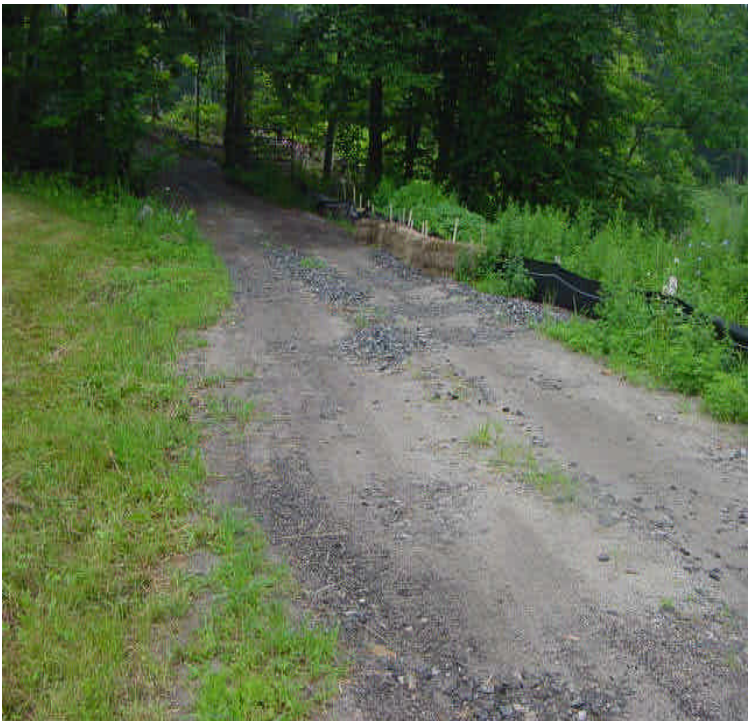
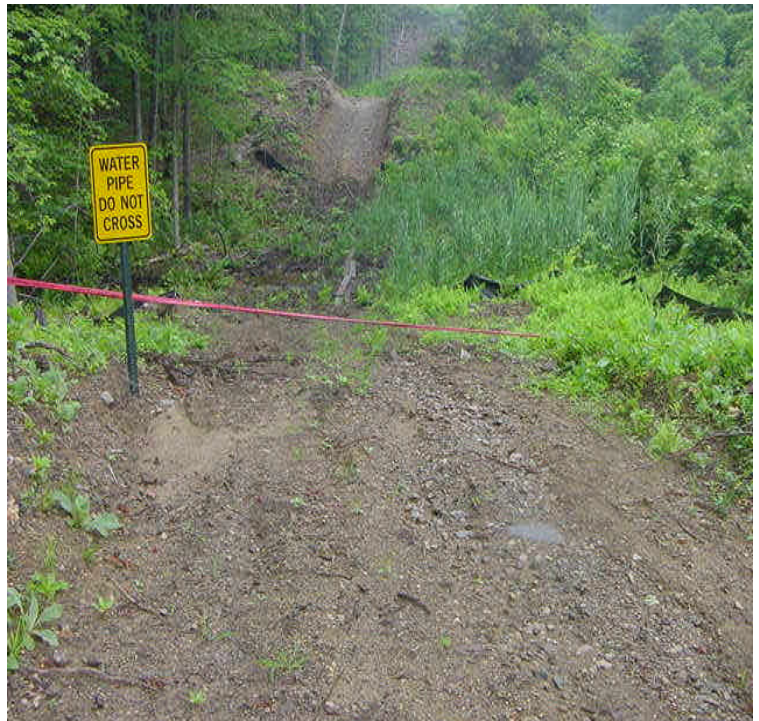
**(345kV H-Frame):** Photo on the left shows controls remaining in good shape at the access road to the ROW at Bethel reservoir. Photo on the right shows where vegetation is returning to the wetland crossing here. Haybales should still be staked in place across the road on either side of the wetland. 7/12/06.

- Non project related vehicles had not returned to the wetland between #10-11 but damage remains. Some vegetative growth was noted 7/12/06	- Haybales should be added across the access road on both side of the wetland to reduce sedimentation. 5/25-7/12/06	-Needs attention (the majority of disturbance is from non project related vehicles)
<b>Norwalk Section</b>	-Off Kent Rd north, it was not directly observed, but crews stated silt fence was extended at the resource areas as recommended 7/12/06.	-Confirm that the controls are in place as intended. 7/12/06.	-Erosion controls were extended

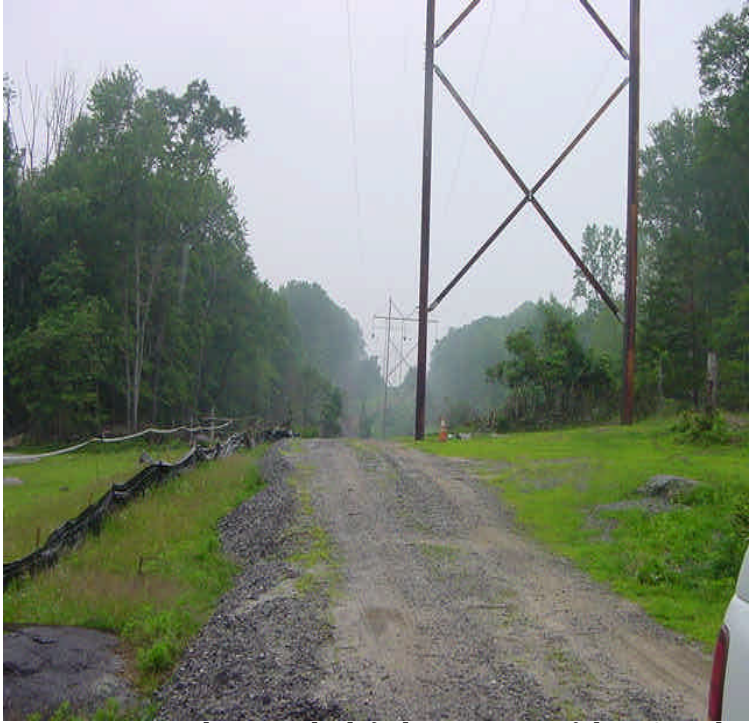
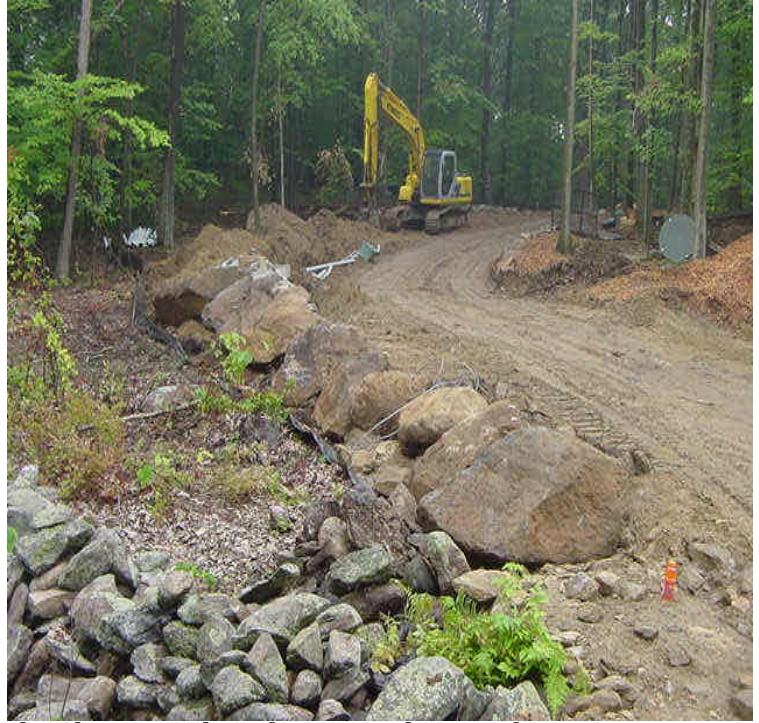
**Photo on the left shows a view of the ROW along the Chestnut Ridge Rd section. Photo on the right shows the residential contractor working near structure #24. The contractor placed boulders on his silt fence here. 7/12/06**

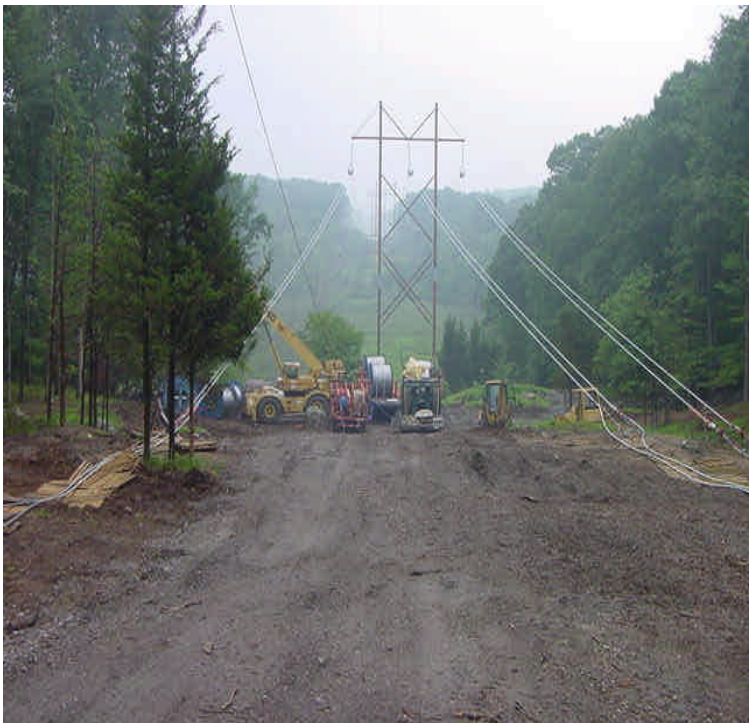
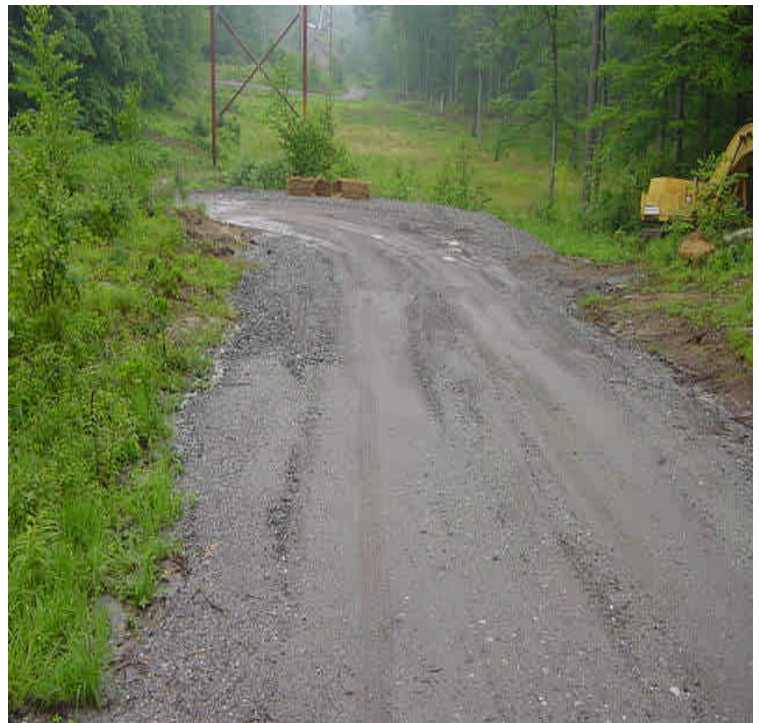
**Photo on the left shows the wire pulling continuing near John Todd Way. Photo on the right shows where the access road was regraded following washouts near structure #31. Haybales were in place. 7/12/06.**

- The access road erosion near structure #31 was regraded and a haybale check dam was observed. 7/12/06.	-Continue to monitor and fill in constructed swale if not already done. 7/12/06	-Haybales were noted. We just need to confirm the swale was filled in.

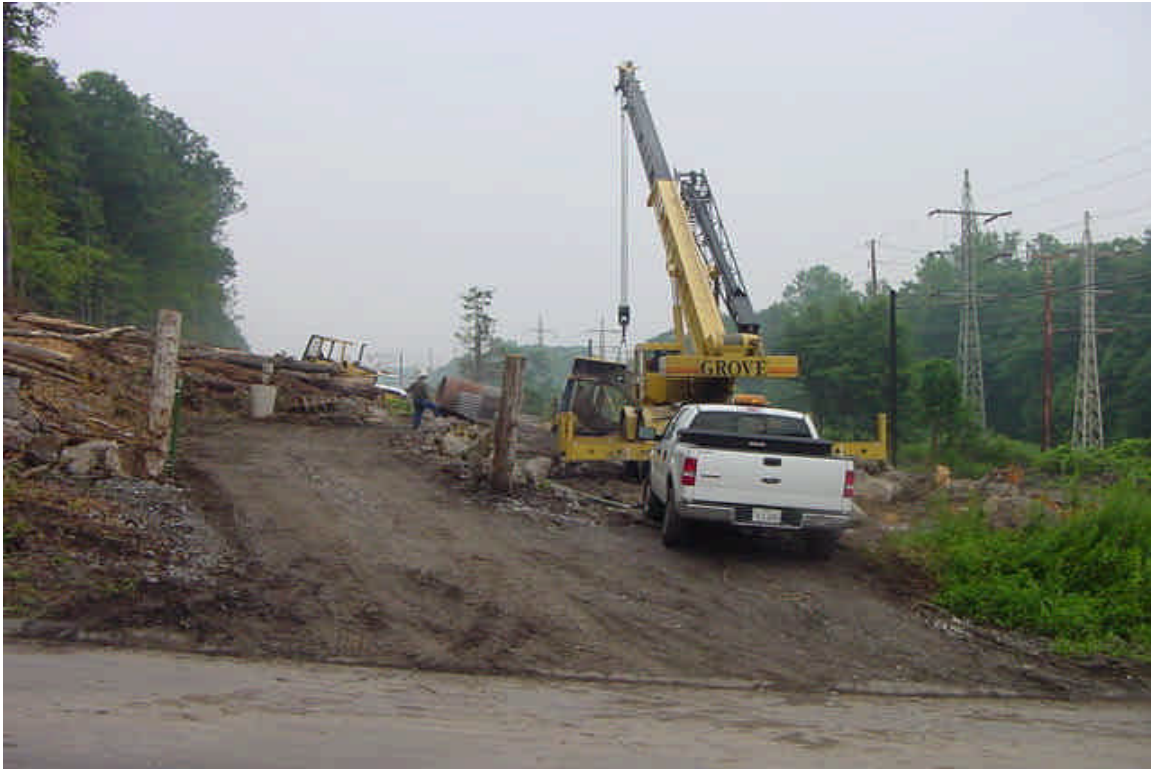
**(Kent Rd) Photo shows foundation reinforcement work at the first pole location north of Kent Rd. The stone access to the road is clogged with sediment and this is flowing to and tracking to the roadway. This needs to be swept and the entrance improved. 7/12/06.**

- Stone dust and/or gravel access roads are in place at Perry Ave and Broad St. 4/6-7/12/06.	- Controls are in place. 7/12/06.	- N/A at this time
	- The Kent Rd (north) stone access pad is clogged with sediment, and dirt is tracking on the roadway. 7/5-7/12/06.	- The stone pad should be cleaned out and improved and sediment should be swept from the roadway This has worsened with the rain. 7/5-7/12/06.	- Needs attention ASAP
	-A new crossing was constructed by the railroad over the tracks to the Wilton Terrace portion of the ROW from Arrowhead Rd. 7/12/06	- None at this time. 7/12/06	-N/A

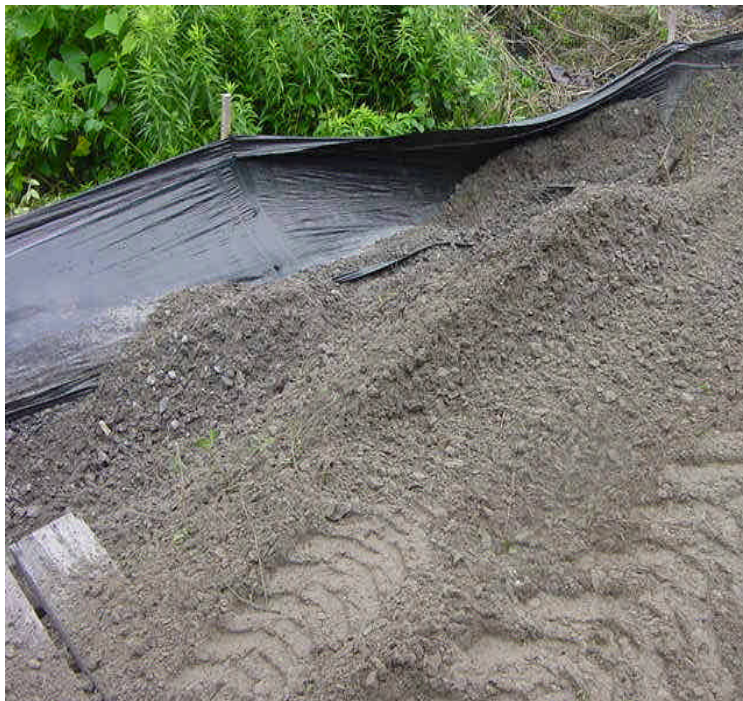
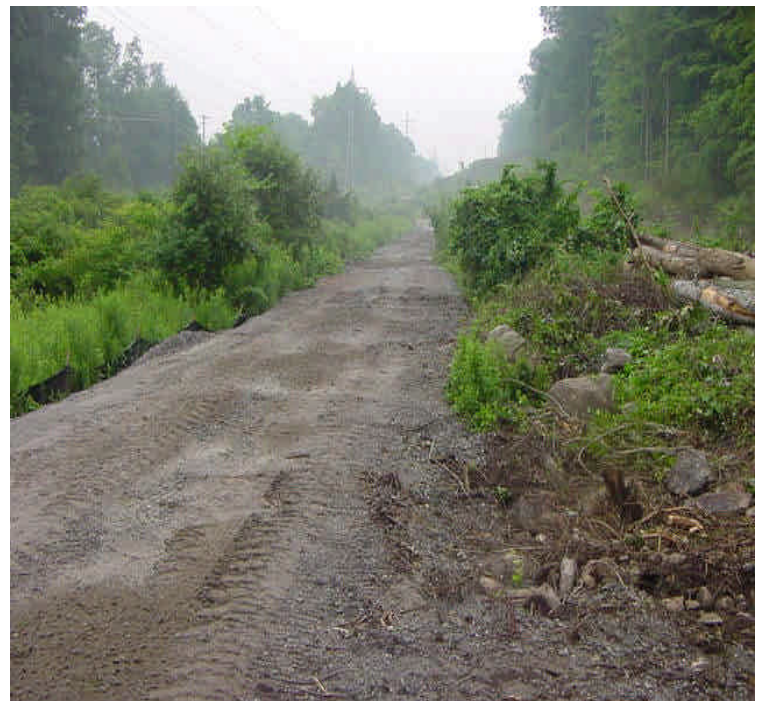
**Photo on the left shows where stone and sediment were being pulled back from overwhelmed portions of silt fence along the access road to the south of Kent Road. Haybales will be installed here as reinforcement. Photo on the right shows an overview of the access road. 7/12/06**

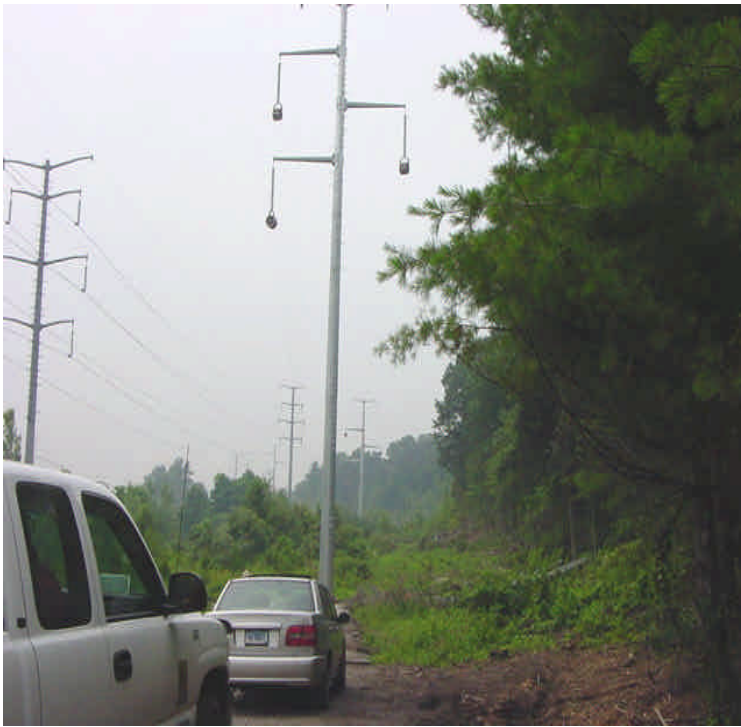
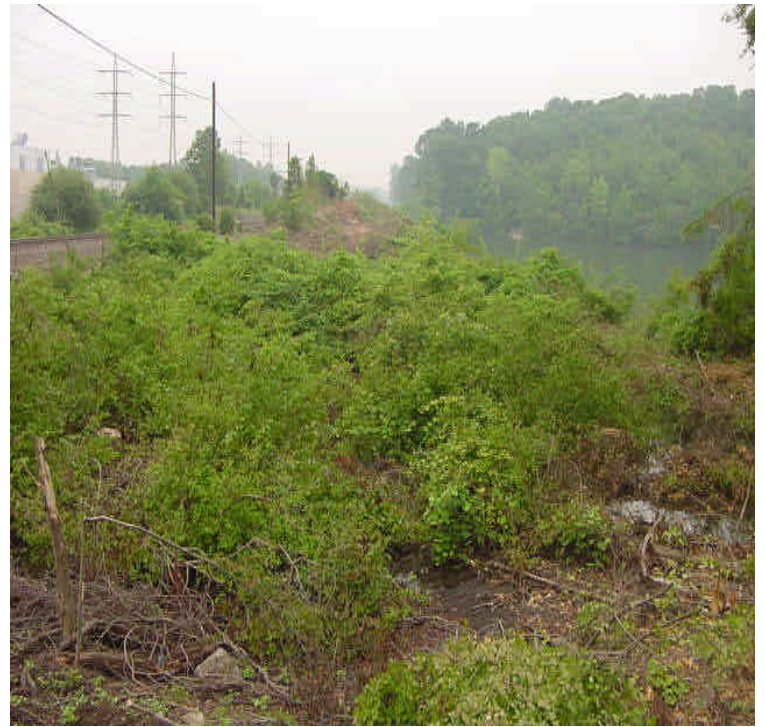
**Photo on the left shows the newly installed structure #67 in the vicinity of North Seir Hill Rd. Photo on the right shows the edge of a wetland area near a proposed foundation location adjacent to the pond. This pole location will be pulled back as far as possible from the wetland. 7/12/06**

- Some access impact may occur at the edge of a wetland near the Kent Rd pond in order to access a foundation location. 6/28-7/12/06	- Mats and controls will be utilized in this area and the location will be moved back even farther. 6/28-7/12/06	-N/A at this time
<b>All Sections</b>	- Use caution in clearing trees from wetland areas. Avoid creating ruts when skidding them out. 3/29-7/12/06.	- Retain shrubs and low growth as much as possible, especially at stream buffers. 3/2-7/12/06.	- N/A
	-If a wetland is being	-Carefully remove brush	-N/A

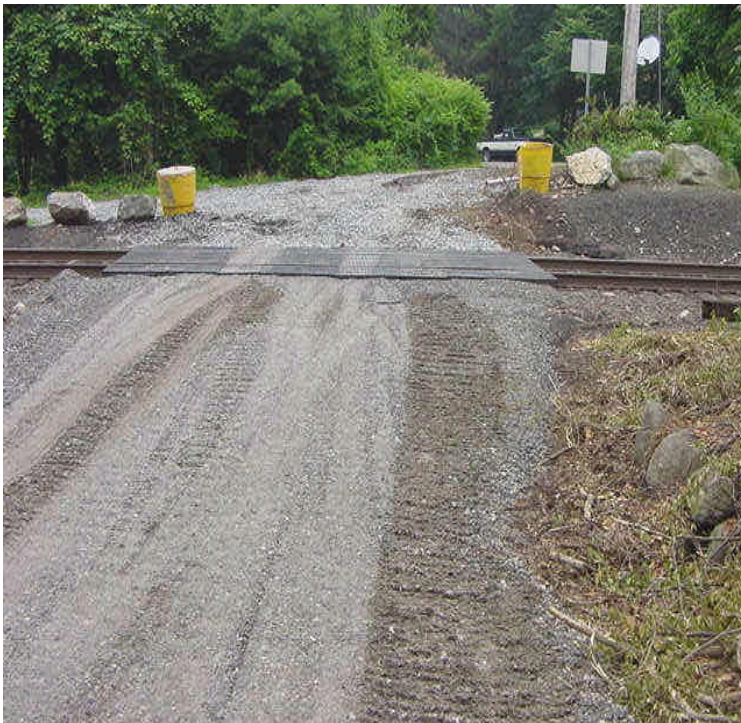
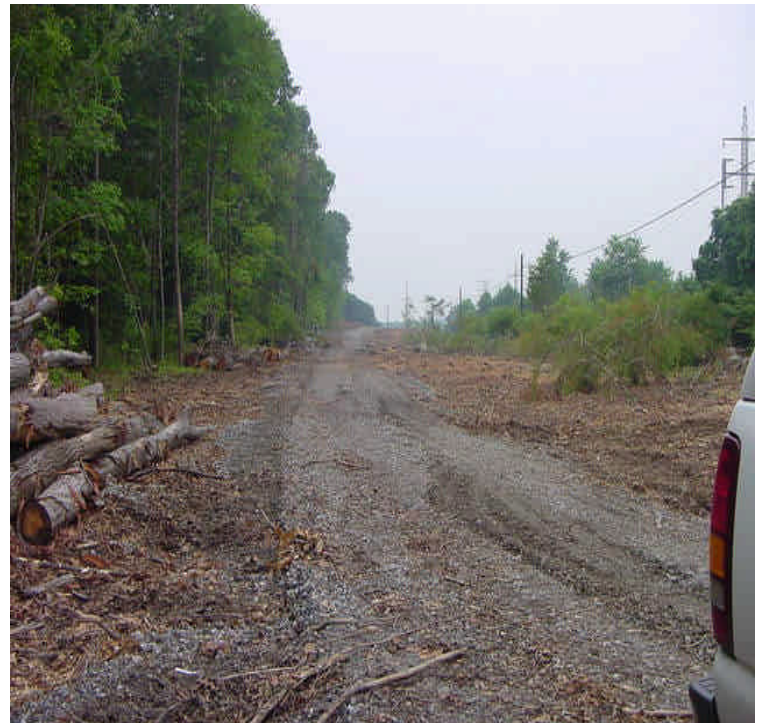
**Photo on the left shows the new crossing constructed by the railroad from Arrowhead Rd to the Wilton Terrace portion of the ROW (north of the pond). Photo on the right shows an overview of this portion of the ROW following clearing. 7/12/06**
